# CQU where there's smoke there's fire

11.00 pm Friday November 1st 2002

## What Happened

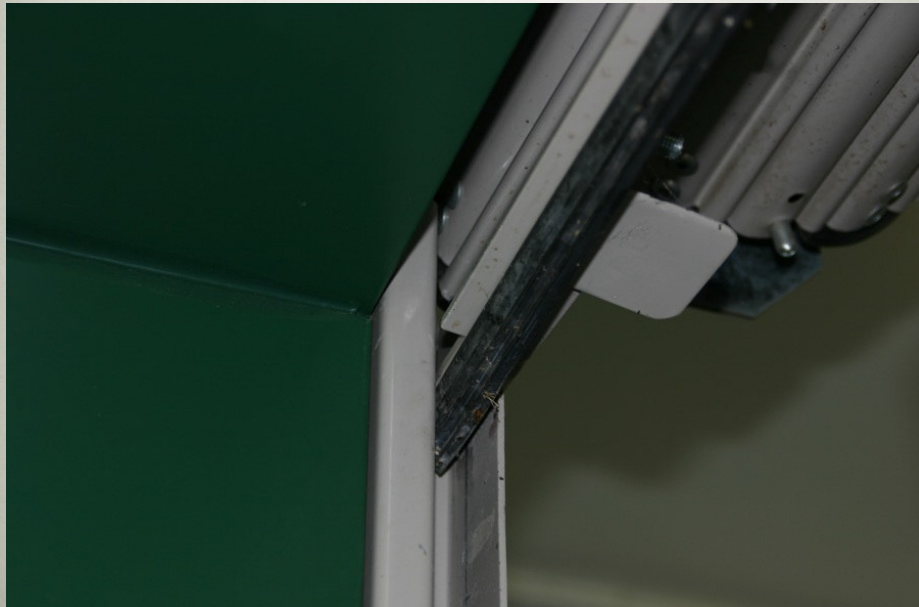
### Roller Door

- Pad mounted transformer issues
- Ceiling height
- Vesda location
- Rollerdoor
- Alternate power supply
- Contractor's bloody contractors!
